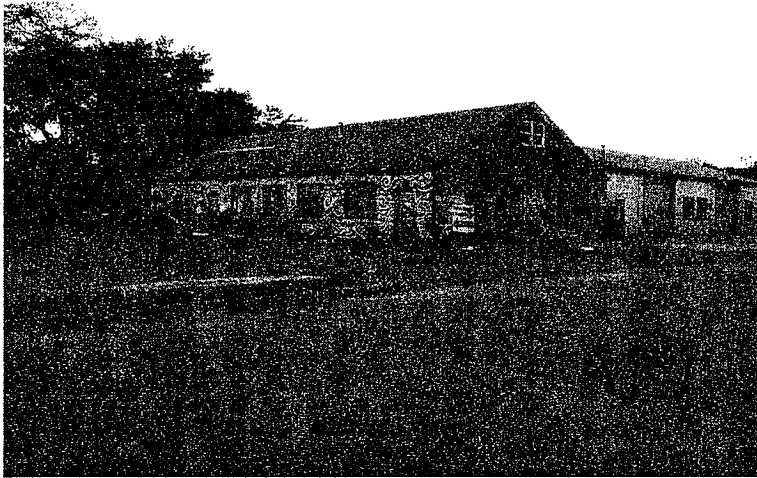
Photograph 1:
View of 1146
Haskell, facing
northeast

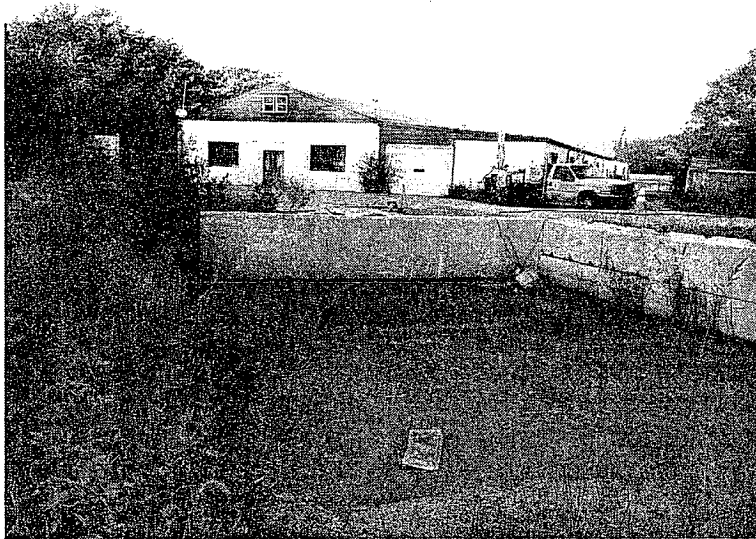
Photograph 2:
View of 1146
Haskell, facing
west

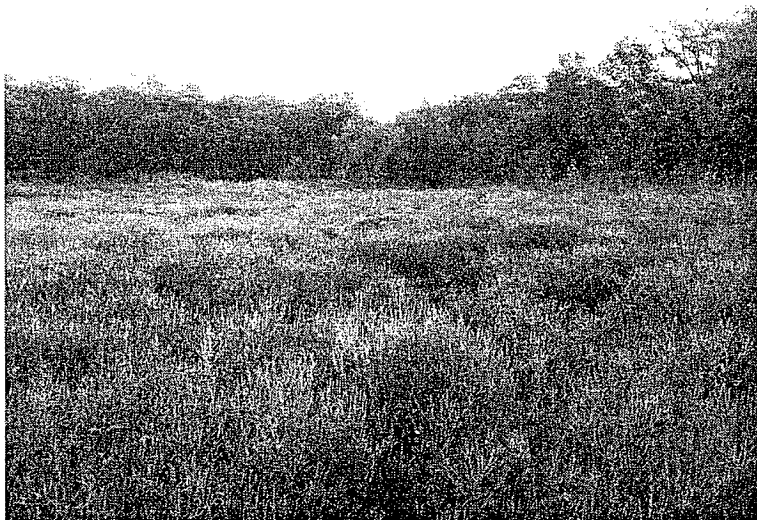
Photograph 3:
View of 1146
Haskell, facing
east-southeast

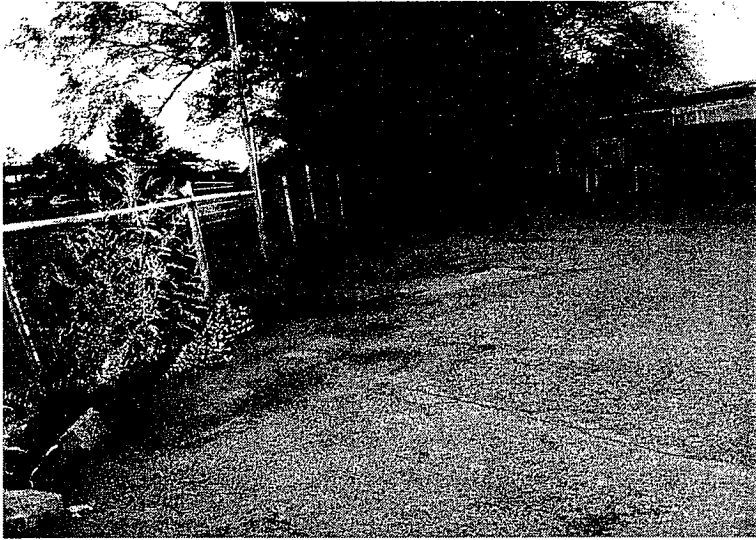
Photograph 4:
View of 1146
Haskell,
northwest corner
by Burroughs
Creek facing east

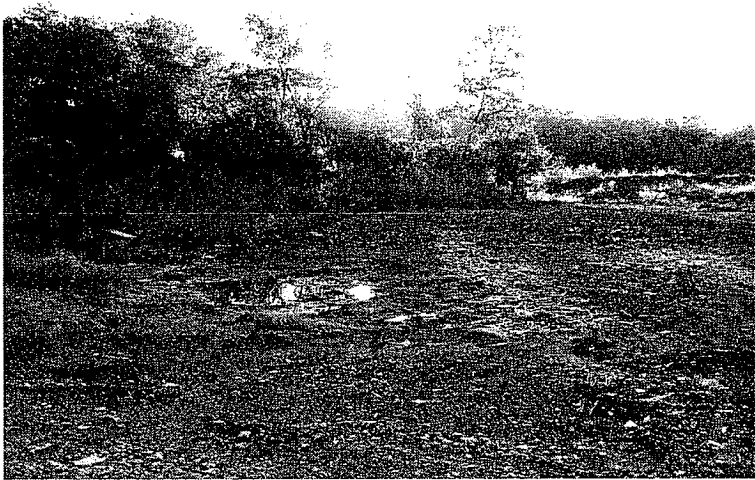
Photograph 5:
View of runoff
collection area
and asphalt in the
background,
facing east

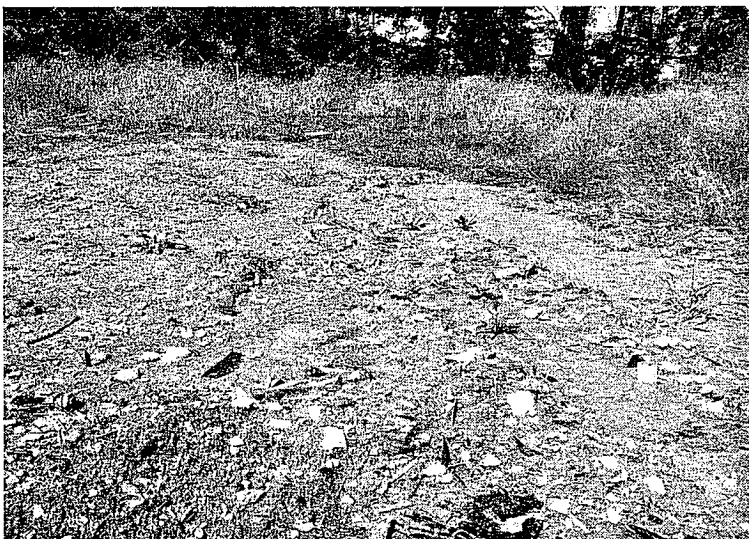
Photograph 6:
View of runoff
collection area
and embedded
debris, facing
north

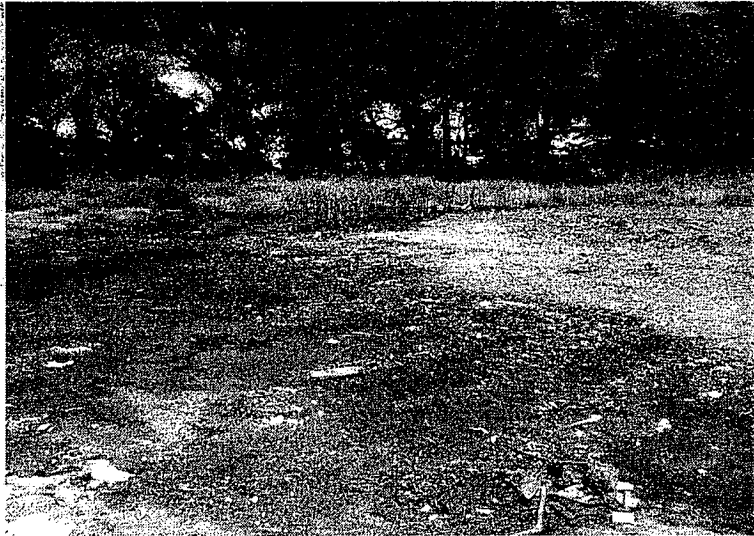
Photograph 7:
View of runoff
collection area,
facing north-
northeast

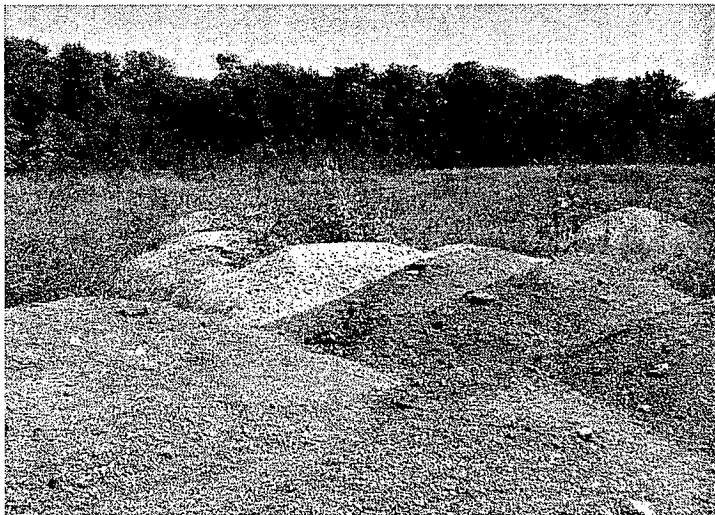
Photograph 8:
View of asphalt
and rock near
north-central
portion of
property, facing
east.

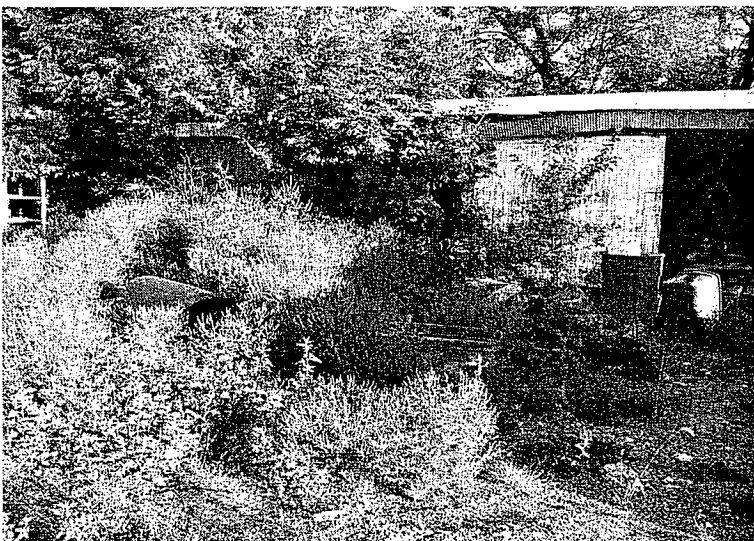
Photograph 9:
View of debris
outside
wooden/metal
building, facing
north-northwest

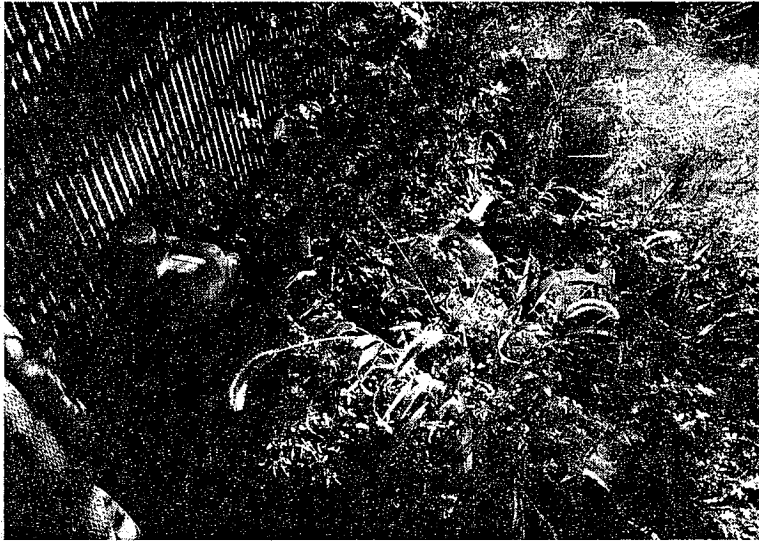
Photograph 10:
View of partially full fuel, paint, and hydraulic fluid containers outside wood/metal building, facing northeast

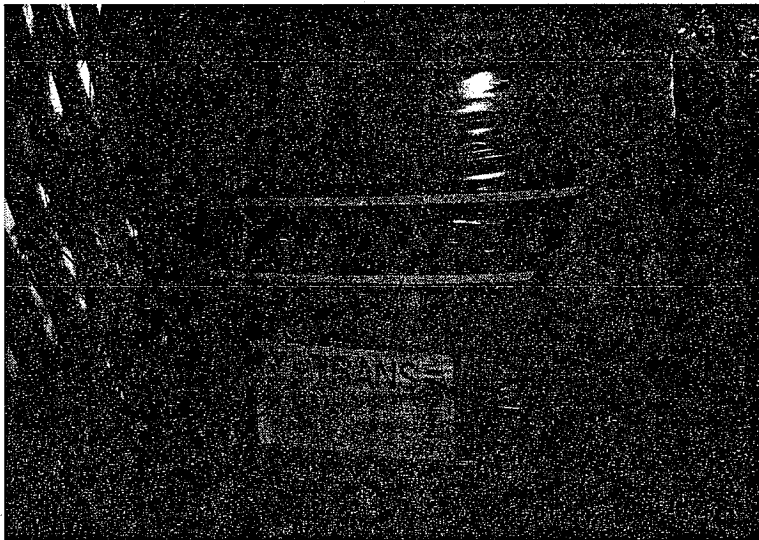
Photograph 11:
View of contents label of hydraulic fuel container outside building, facing northeast

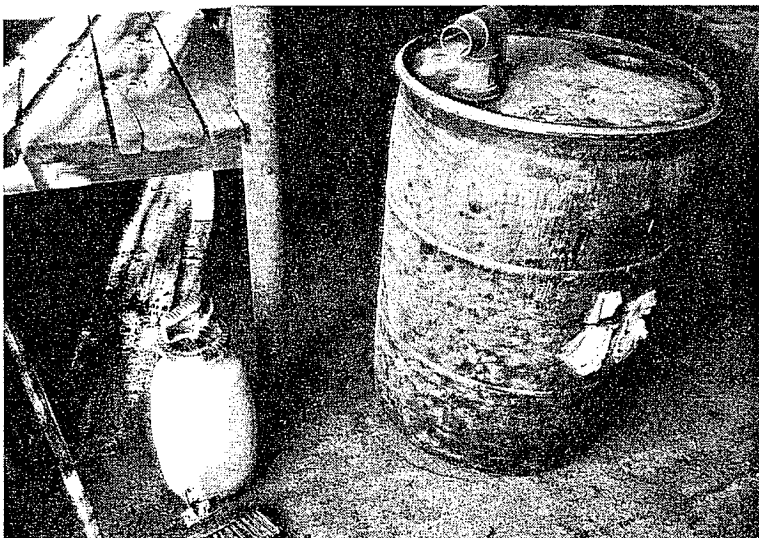
Photograph 12:
View of partially full pesticide container and barrel (contents unknown) inside wood/metal building, facing northwest

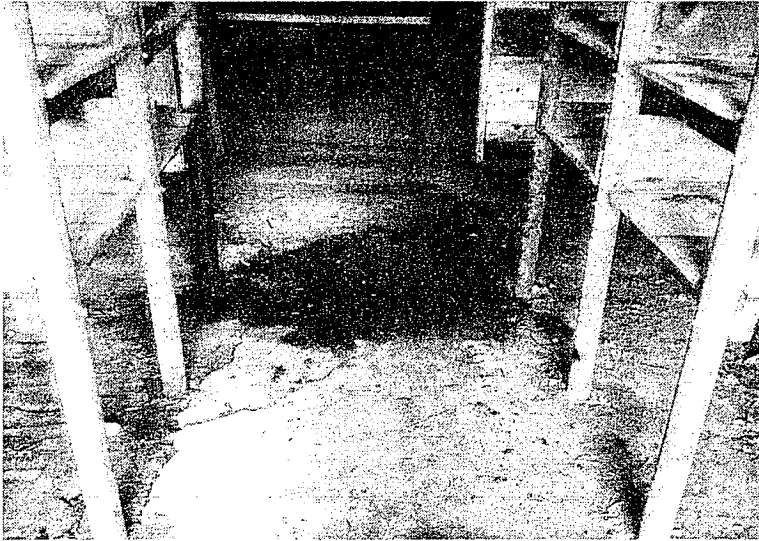
Photograph 13:
View of stain on
concrete floor of
metal/wood
building, facing
north

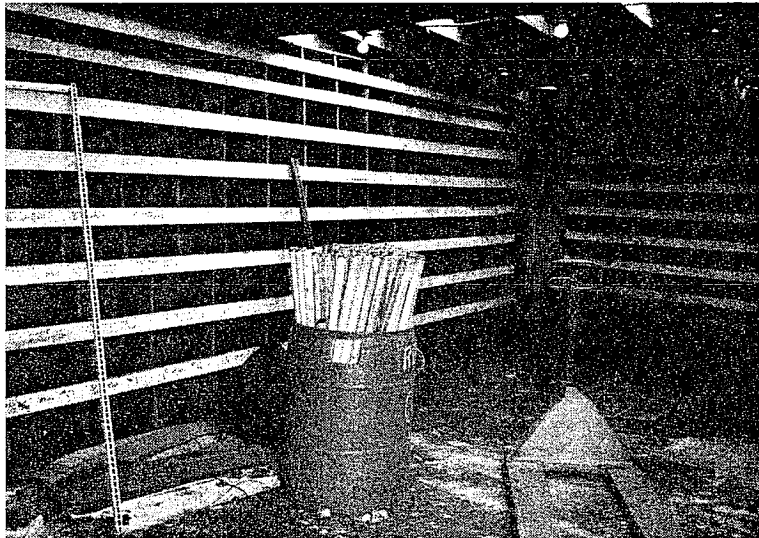
Photograph 14:
View of
fluorescent tube
lights inside
westernmost
wood building,
facing northeast

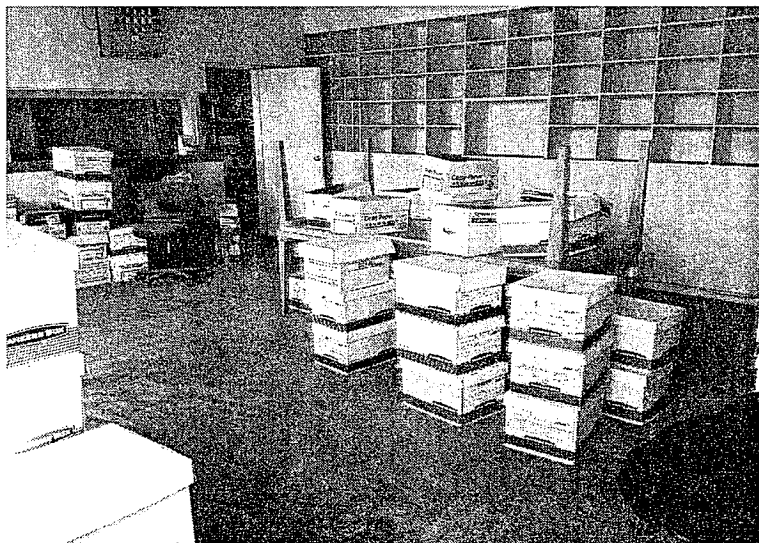
Photograph 15:
View inside main
building showing
office area, facing
northeast

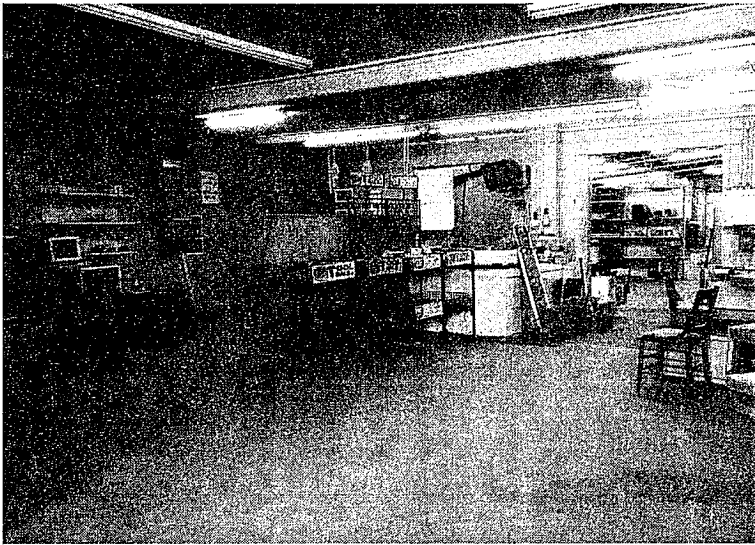
Photograph 13:
View inside main building showing store front, facing northeast

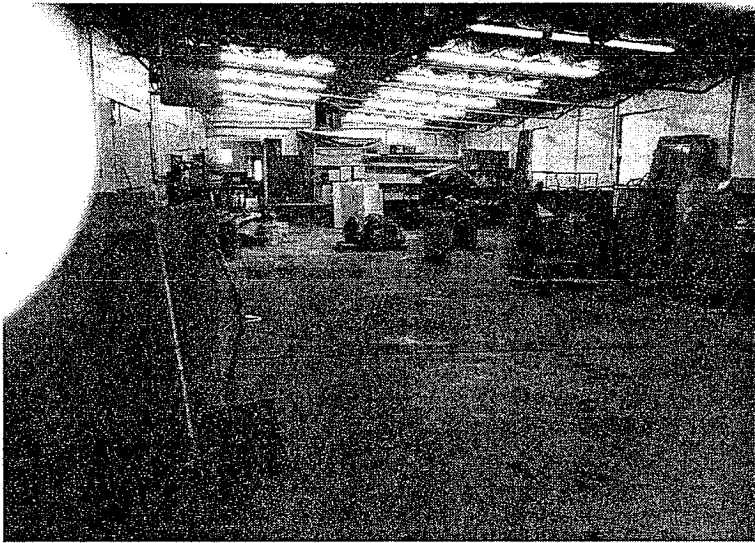
Photograph 17:
View inside main building storage area, facing west

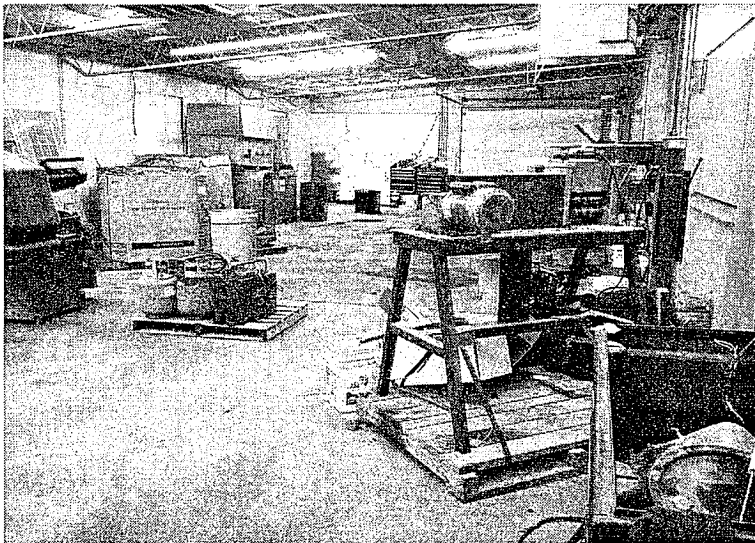
Photograph 18:
View inside main building storage area, facing east

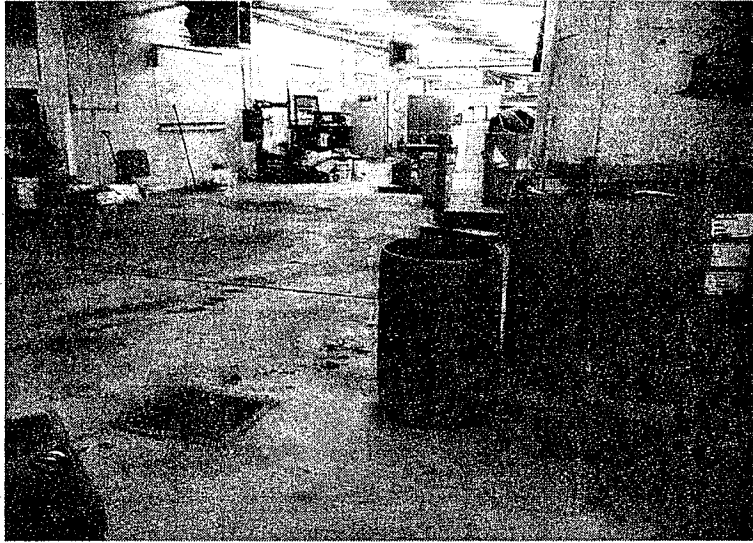
Photograph 19:
View inside main building storage area, facing southwest

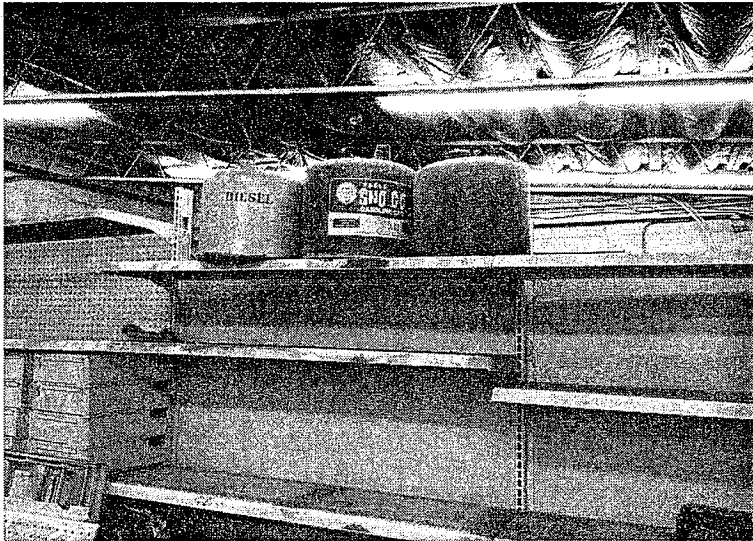
Photograph 20:
View of old fuel cans inside main building storage area, facing west

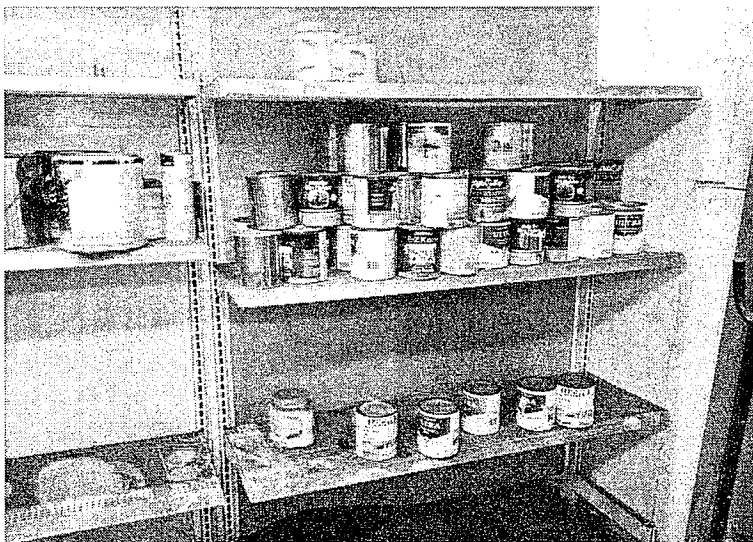
Photograph 21:
View of paint and stain containers inside main building storage area

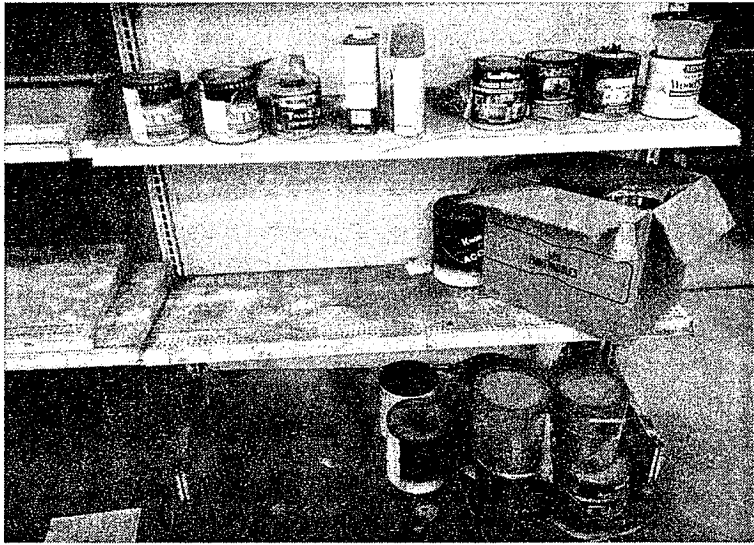
Photograph 22:
View of paint and stain containers inside main building storage area

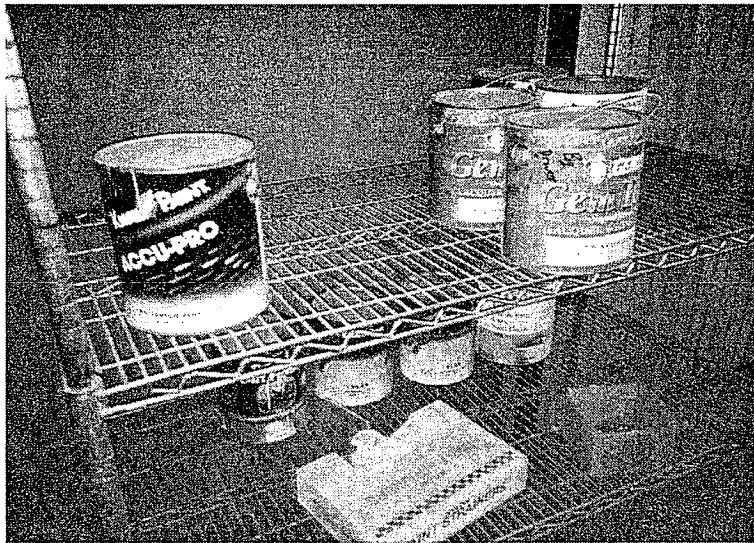
Photograph 23:
View of paint and stain containers inside main building storage area

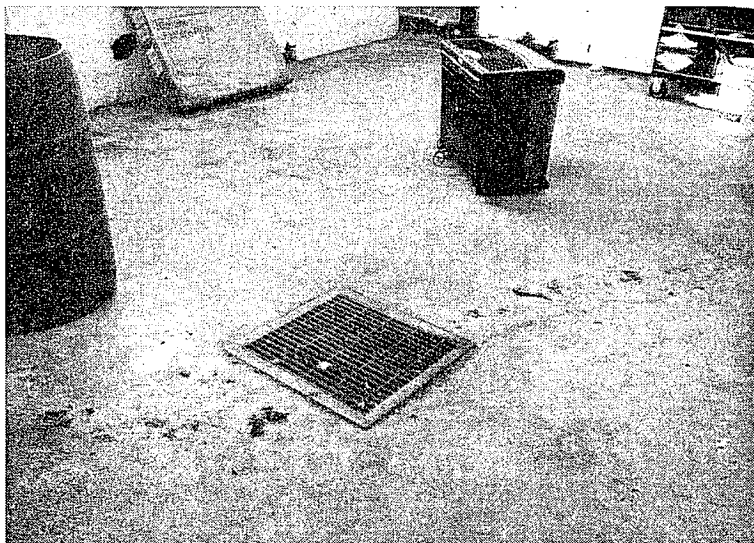
Photograph 24:
View of drain in storage area which was also a former auto service area (drainage point unknown)

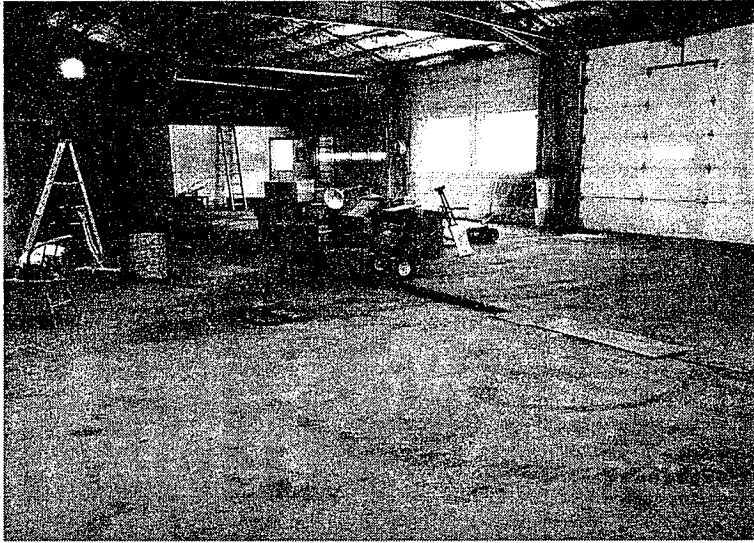
Photograph 25:
View of former
service area in
main building,
facing southeast

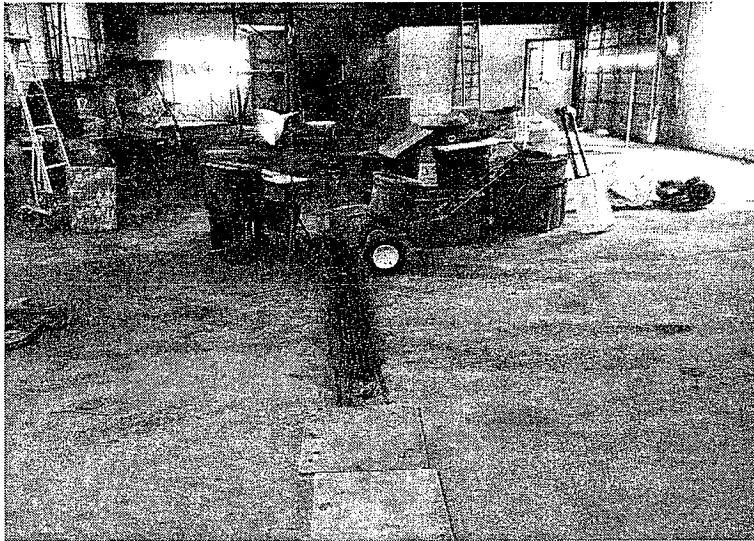
Photograph 26:
View of former
service area in
main building
(broken floor
drain in front),
facing east

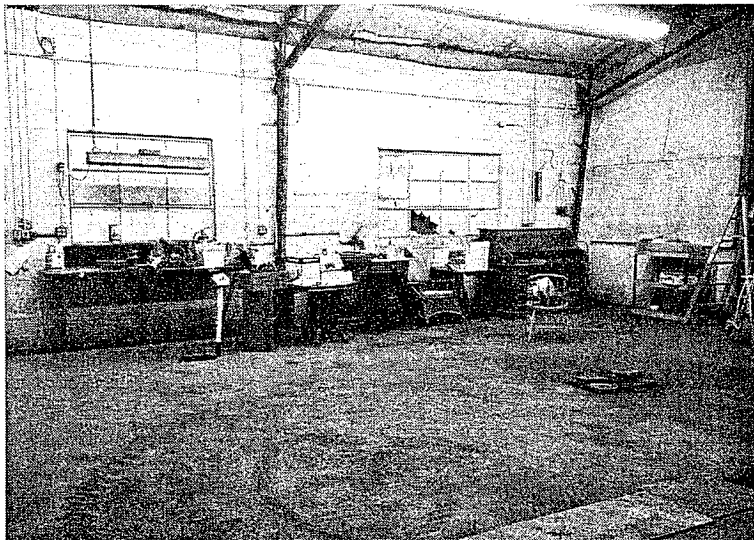
Photograph 27:
View of
workspace in
service area of
main building,
facing northeast

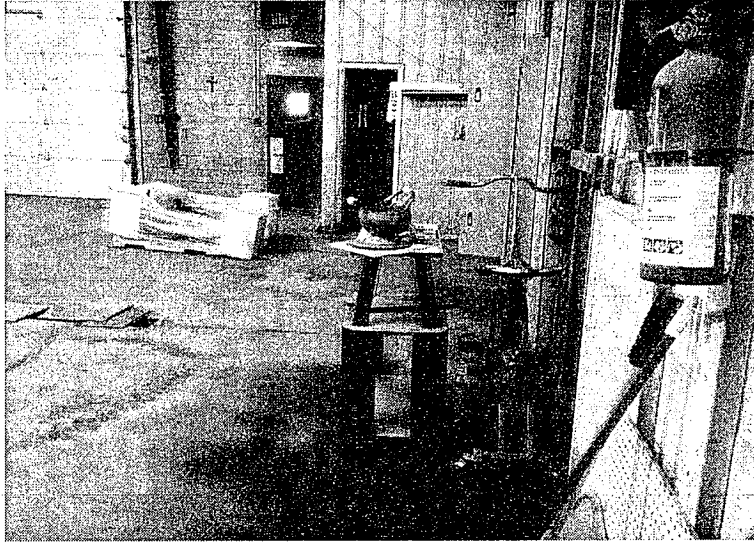
Photograph 28:
View of stained floor inside former service area of main building, facing west

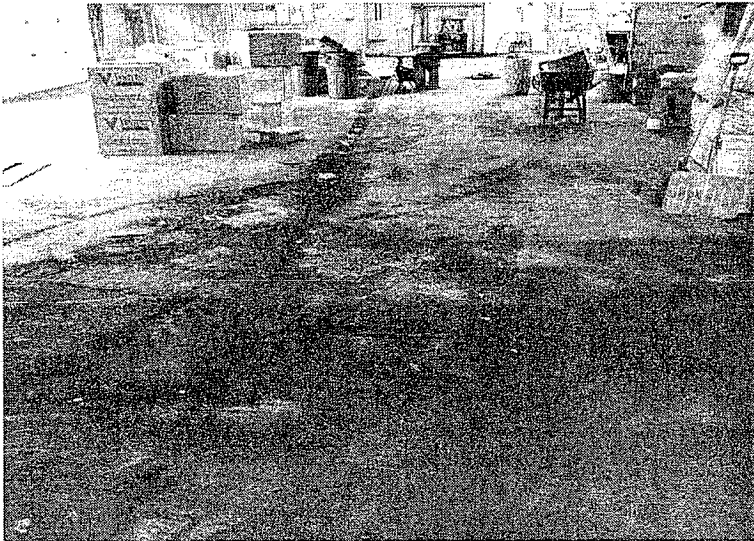
Photograph 29:
View of stained floor near floor drain in service area of main building, facing west

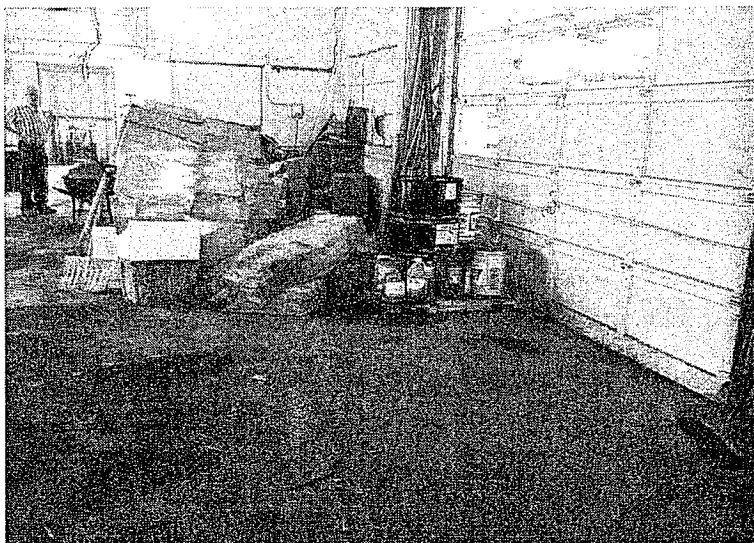
Photograph 30:
View of containers on pallet with stain underneath in service area of main building, facing northwest

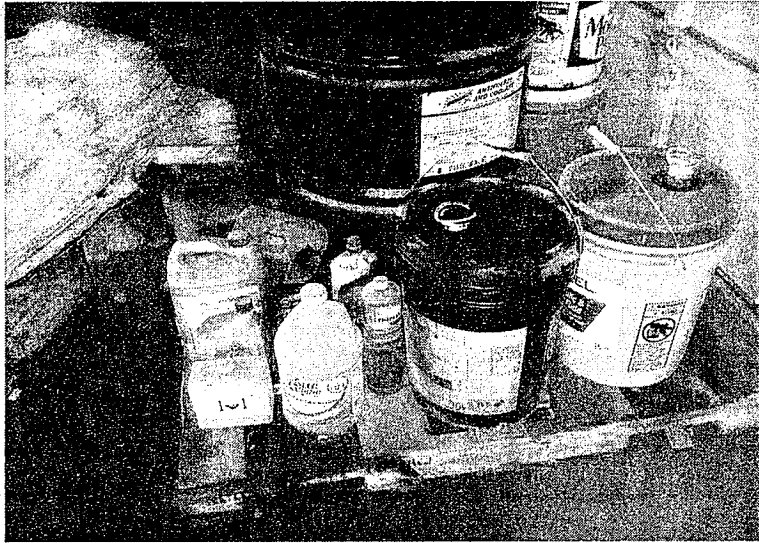
Photograph 31:
View of stained
floor and
containers on
pallet close up,
facing northwest

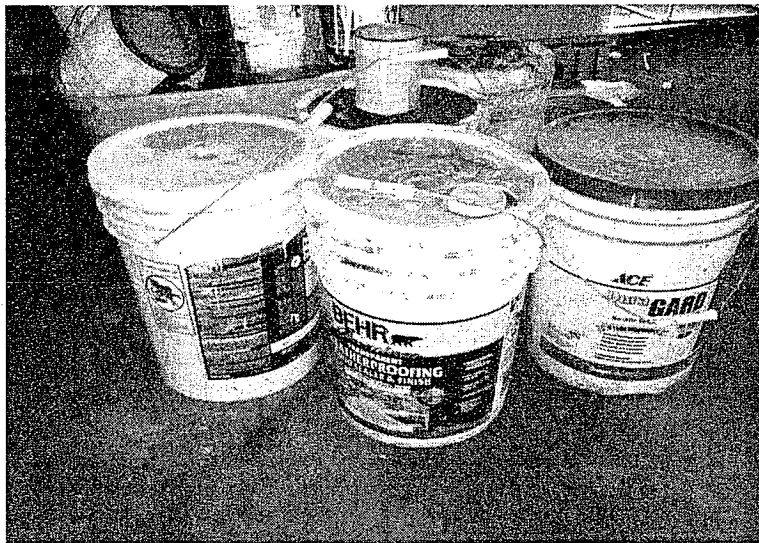
Photograph 32:
View of paint and
weatherproofing
containers in
main building

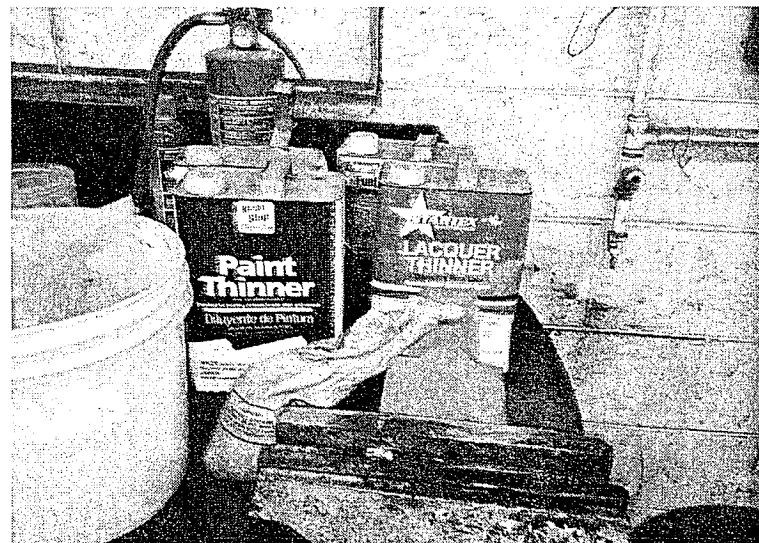
Photograph 33:
View of paint and
lacquer thinner
containers in
main building

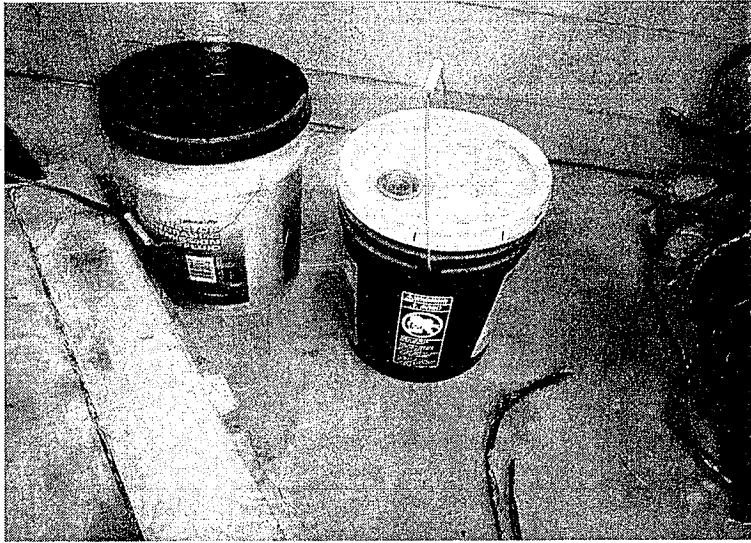
Photograph 34:
View of hydraulic
fluid containers in
main building

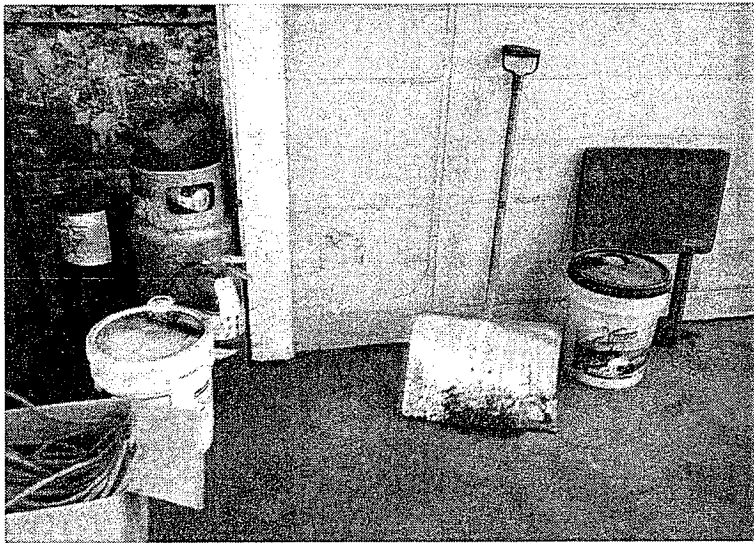
Photograph 35:
View of stained
shovel and floor
in main building

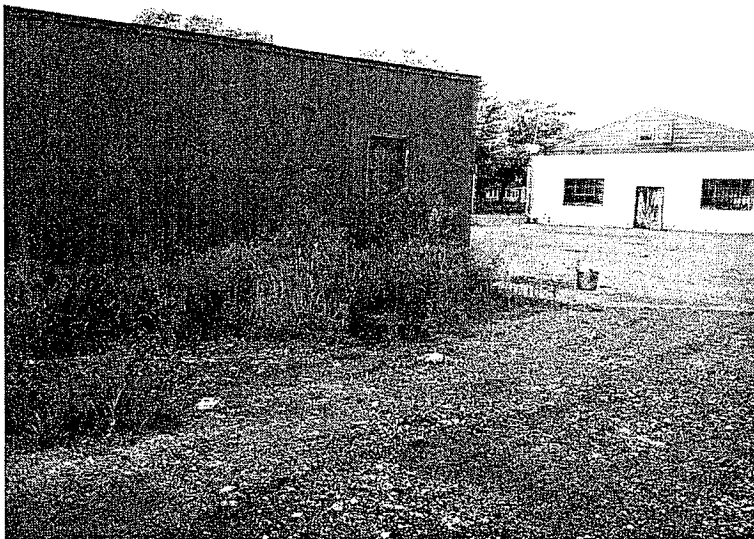
Photograph 36:
View of stained
soil north of the
garage, facing
southwest

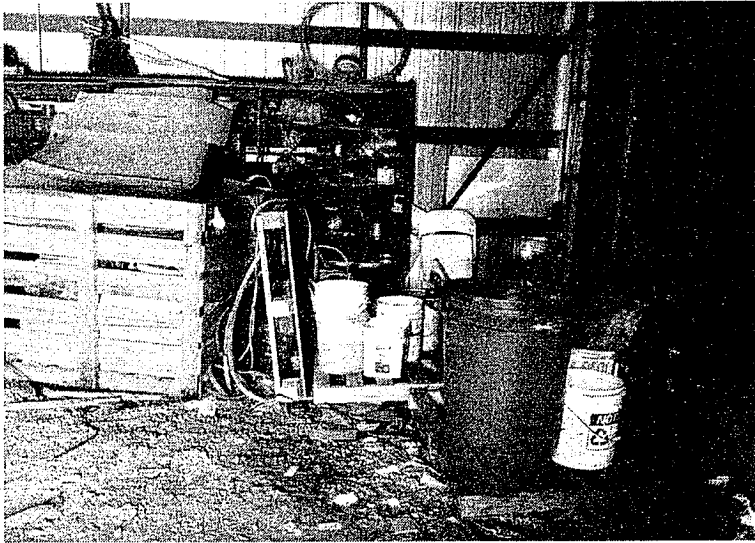
Photograph 37:

View of east garage interior including light fixtures on shelves, facing south

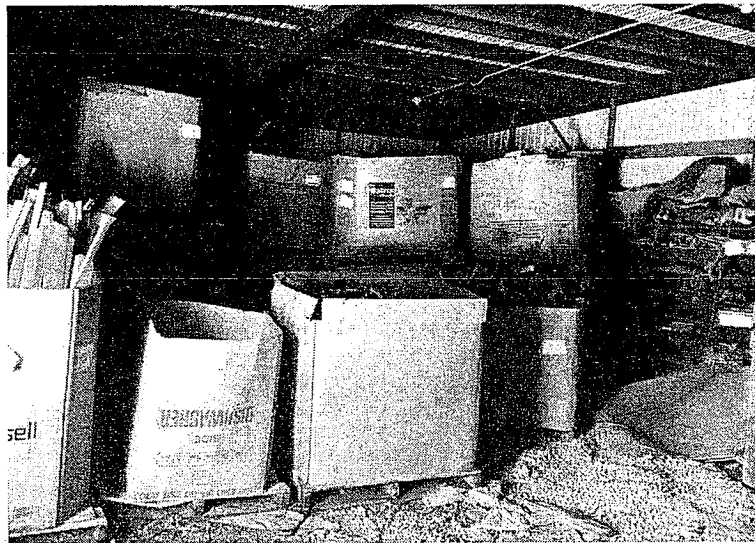
Photograph 38:

View of east garage interior including boxes of scrap metal, facing southeast

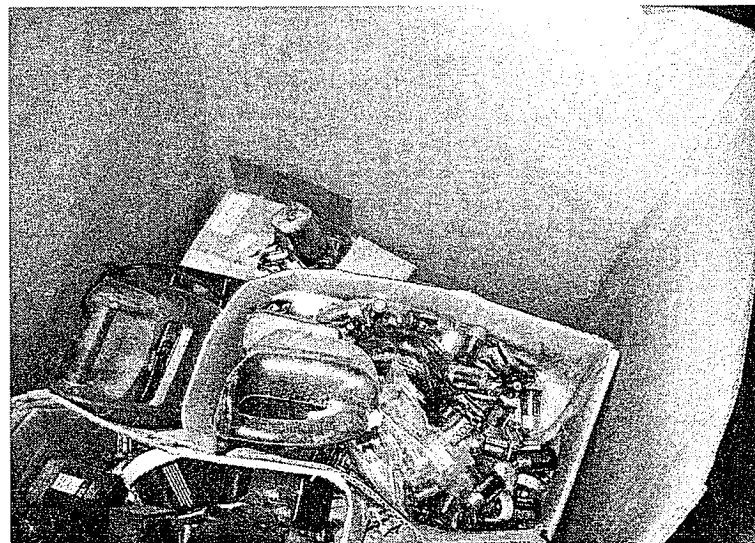
Photograph 39:

View of household batteries in east garage

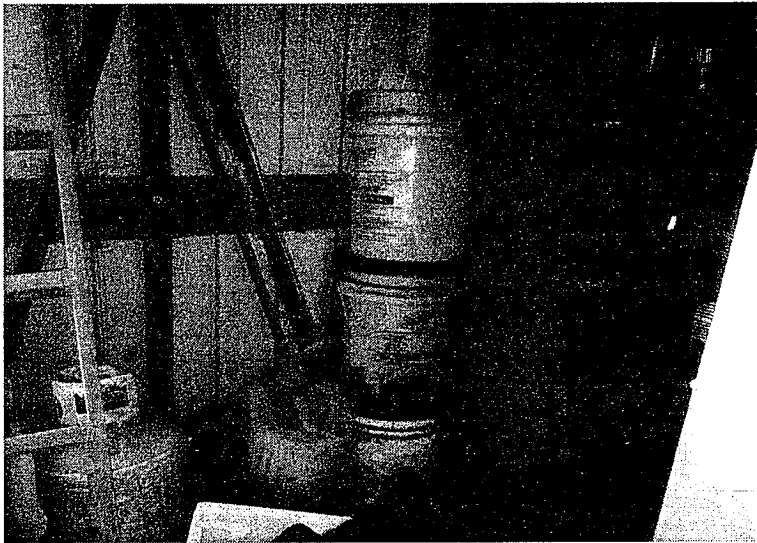
Photograph 40:
View of unlabeled
containers in east
garage, some full
of fluid, possibly
used oil

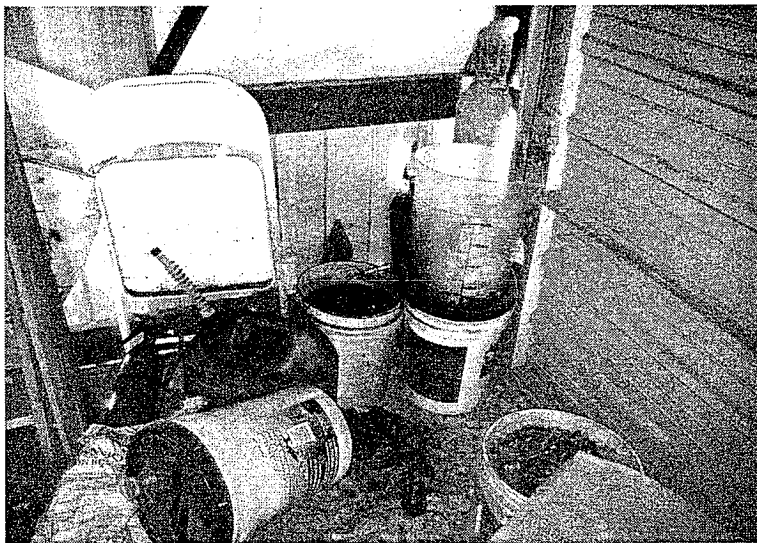
Photograph 41:
View of
containers in east
garage, possible
floor stain,
possible used oil
with no lid
